**EXPANDED SITE INSPECTION REPORT
WILCOX REFINERY
CREEK COUNTY, OKLAHOMA
EPA CERCLIS ID # OK0001010917**

**STATE OF OKLAHOMA
DEPARTMENT OF ENVIRONMENTAL QUALITY
LAND PROTECTION DIVISION
SITE ASSESSMENT UNIT**

Date: September 30th, 2011

Site: Wilcox Refinery, Creek County

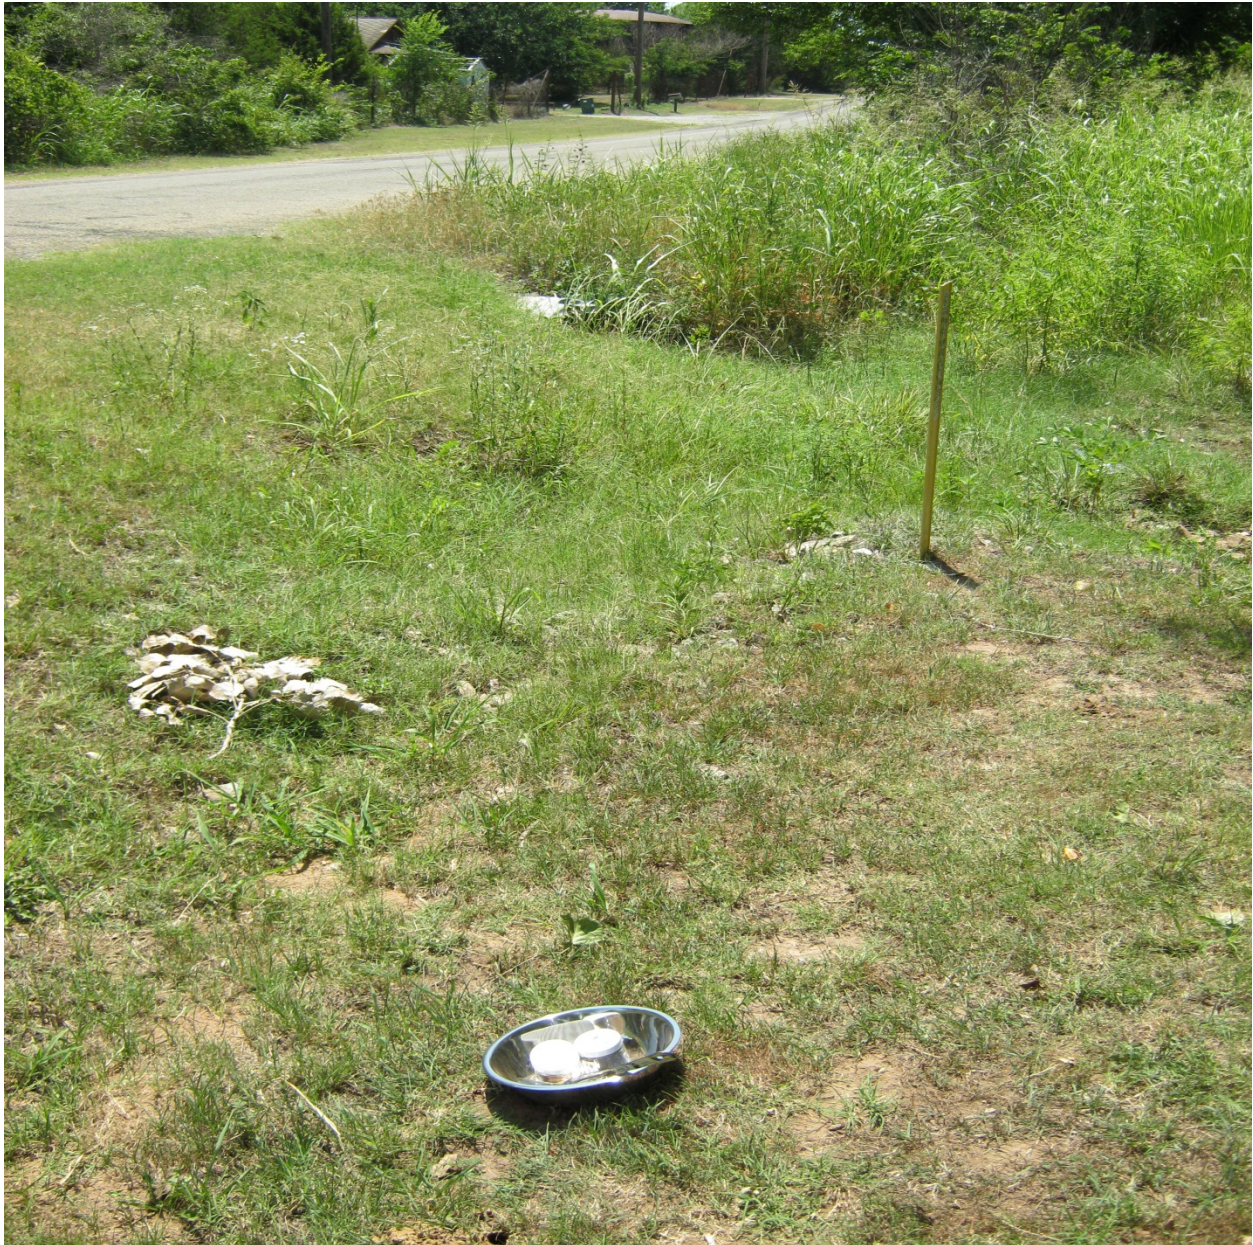
Photo #1

Photographer: Todd Downham Date: 6/28/2011 Direction: Southwest Comments: Surface Soil SS-1 location, north of Refinery Road.

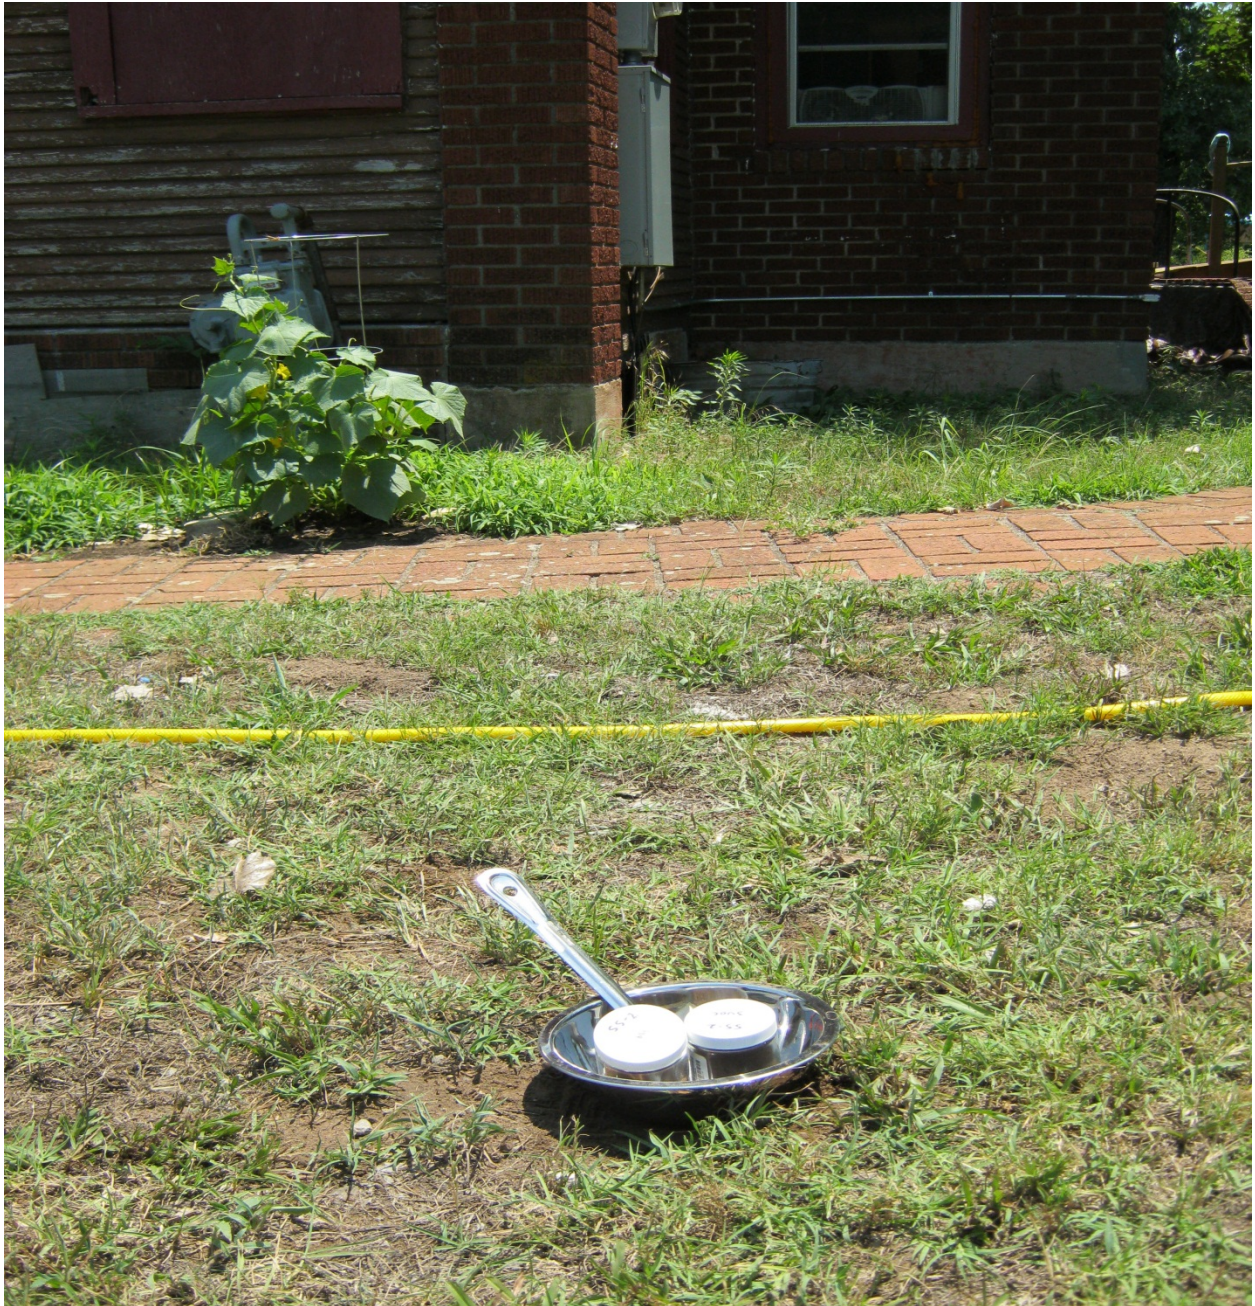
Photo #2

Photographer: Todd Downham Date: 6/28/2011 Direction: South Comments: Surface Soil SS-2 location. Residential yard.

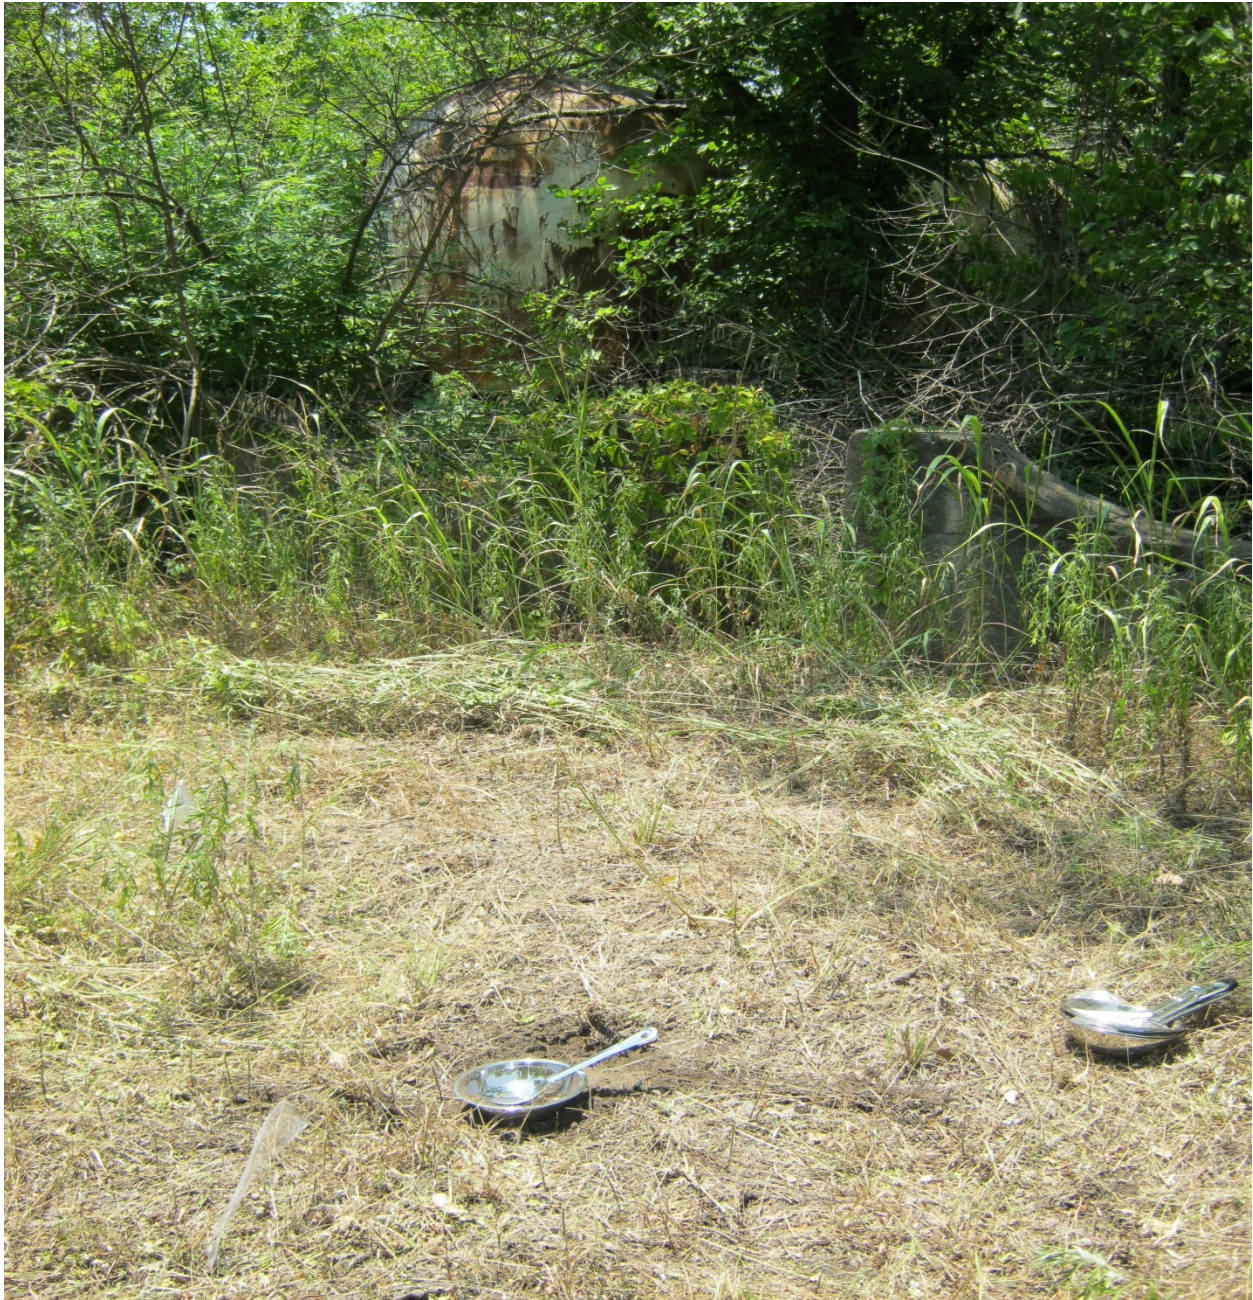
Photo #3

Photographer: Todd Downham Date: 6/28/2011 Direction: Southwest Comments: Surface Soil SS-3 location, collected near large horizontal storage tank.

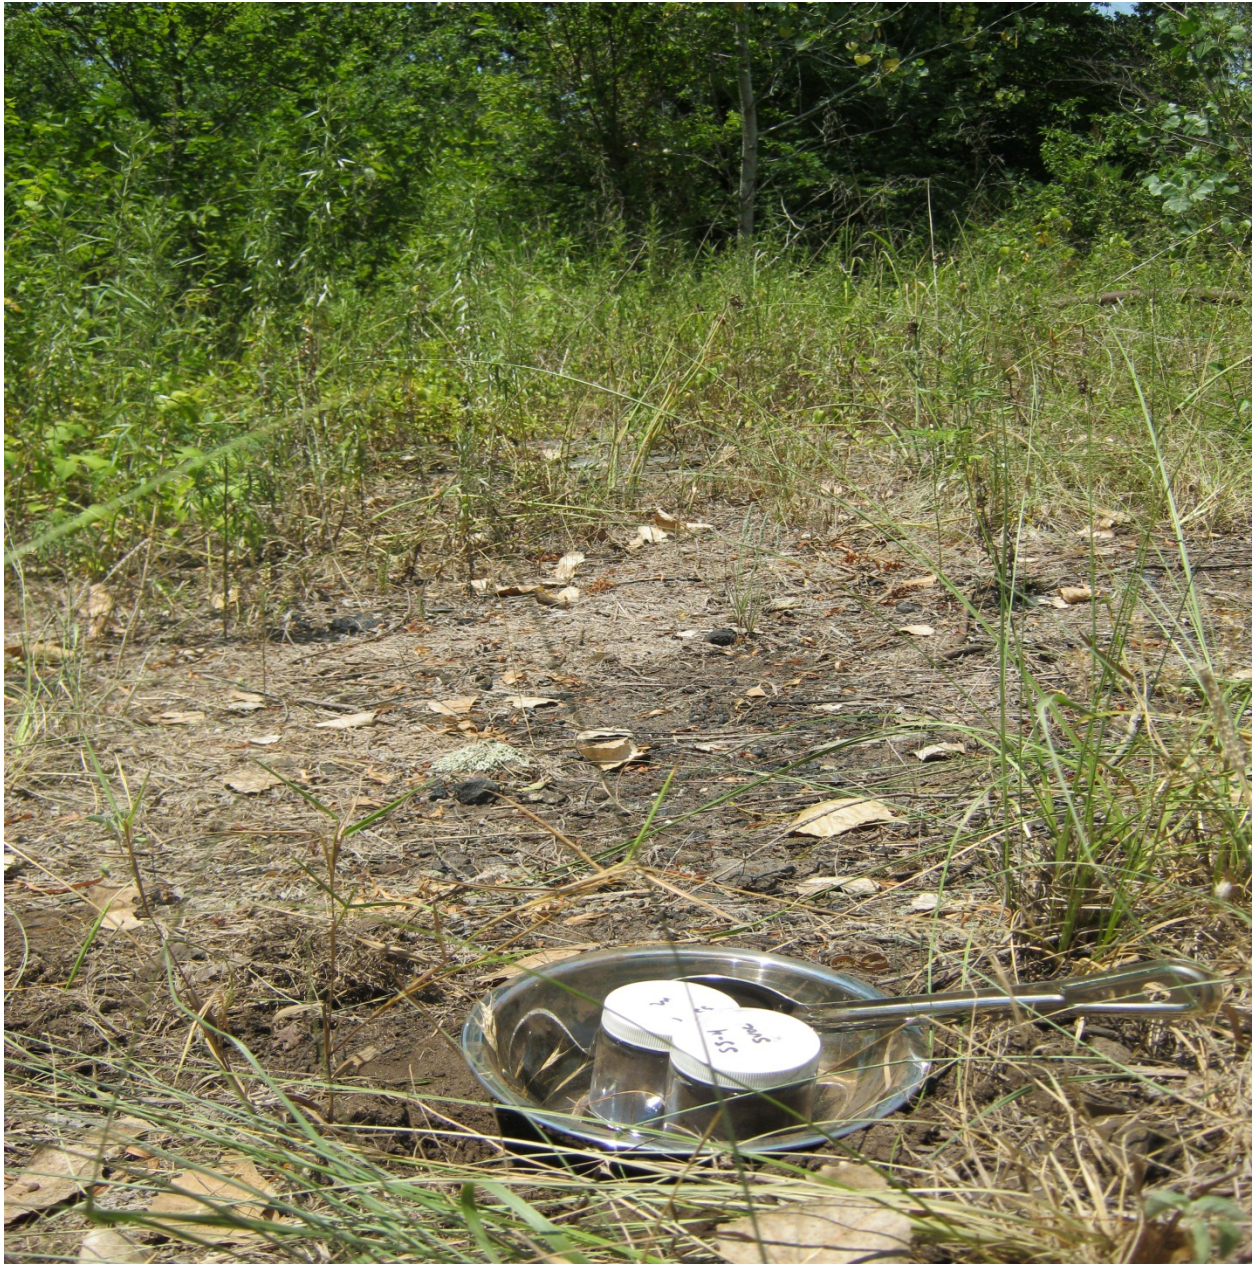
Photo #4

Photographer: Todd Downham Date: 6/28/2011 Direction: West Comments: Surface Soil sample SS-4 location.

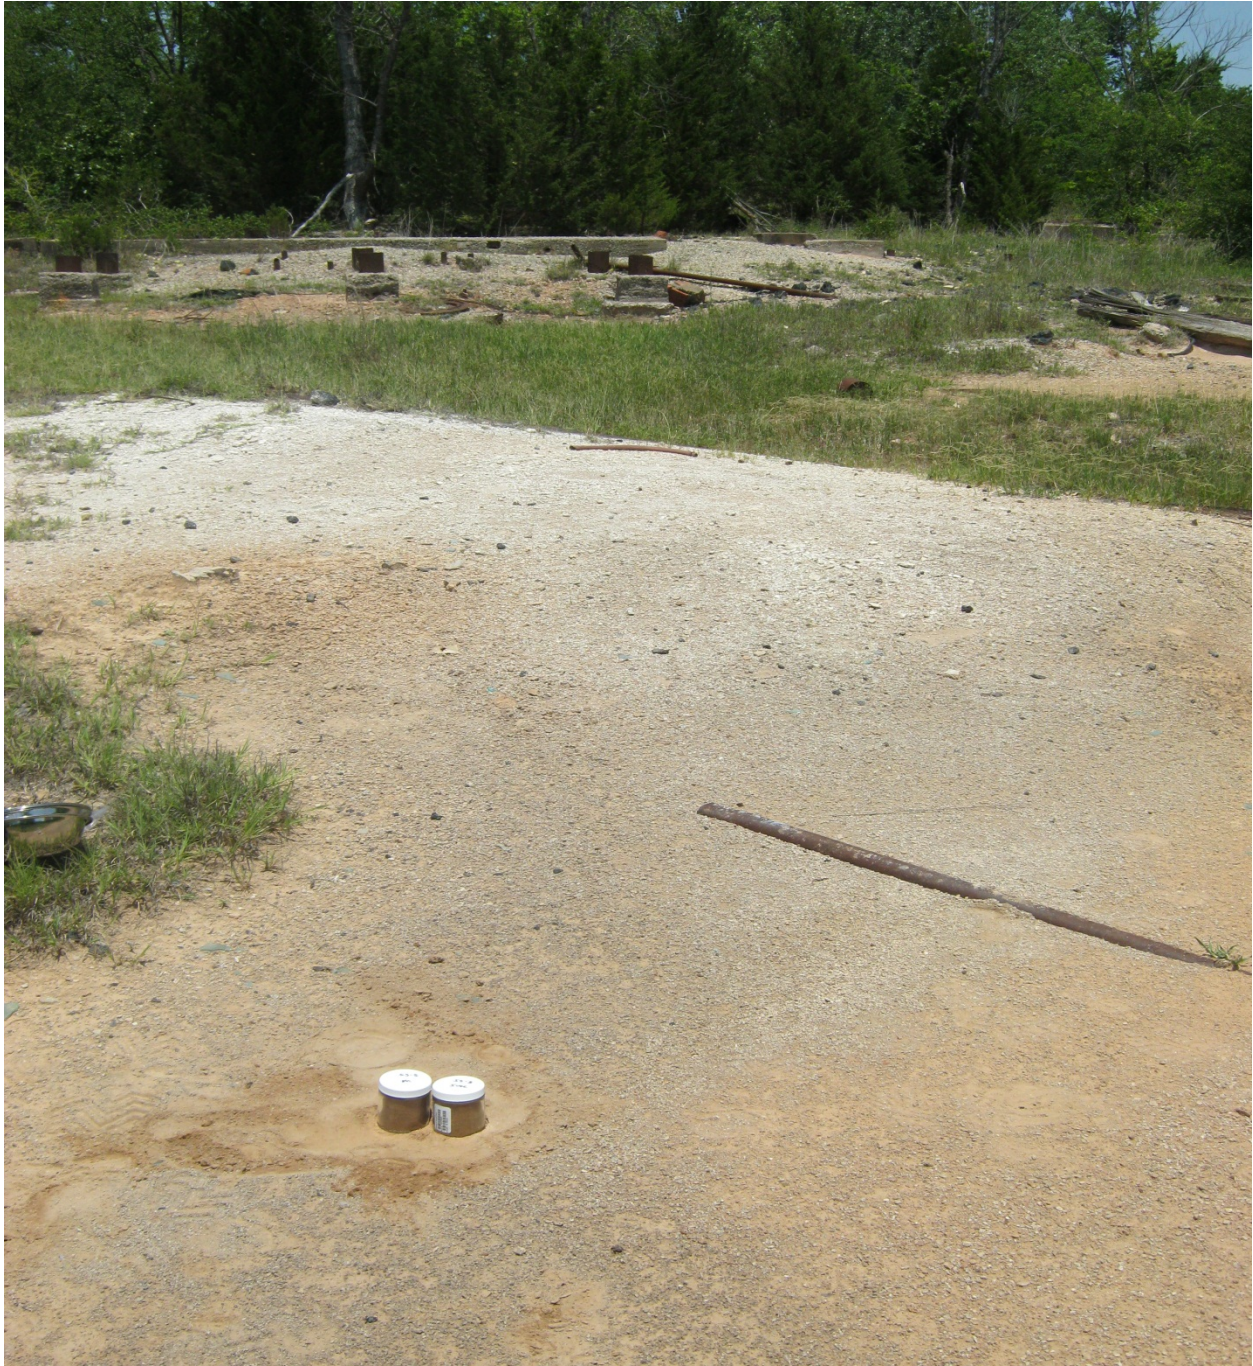
Photo #5

Photographer: Todd Downham Date: 6/28/2011 Direction: North Comments: Surface Soil SS-5 location, large impacted area west of west tributary and pond on the Lee property.

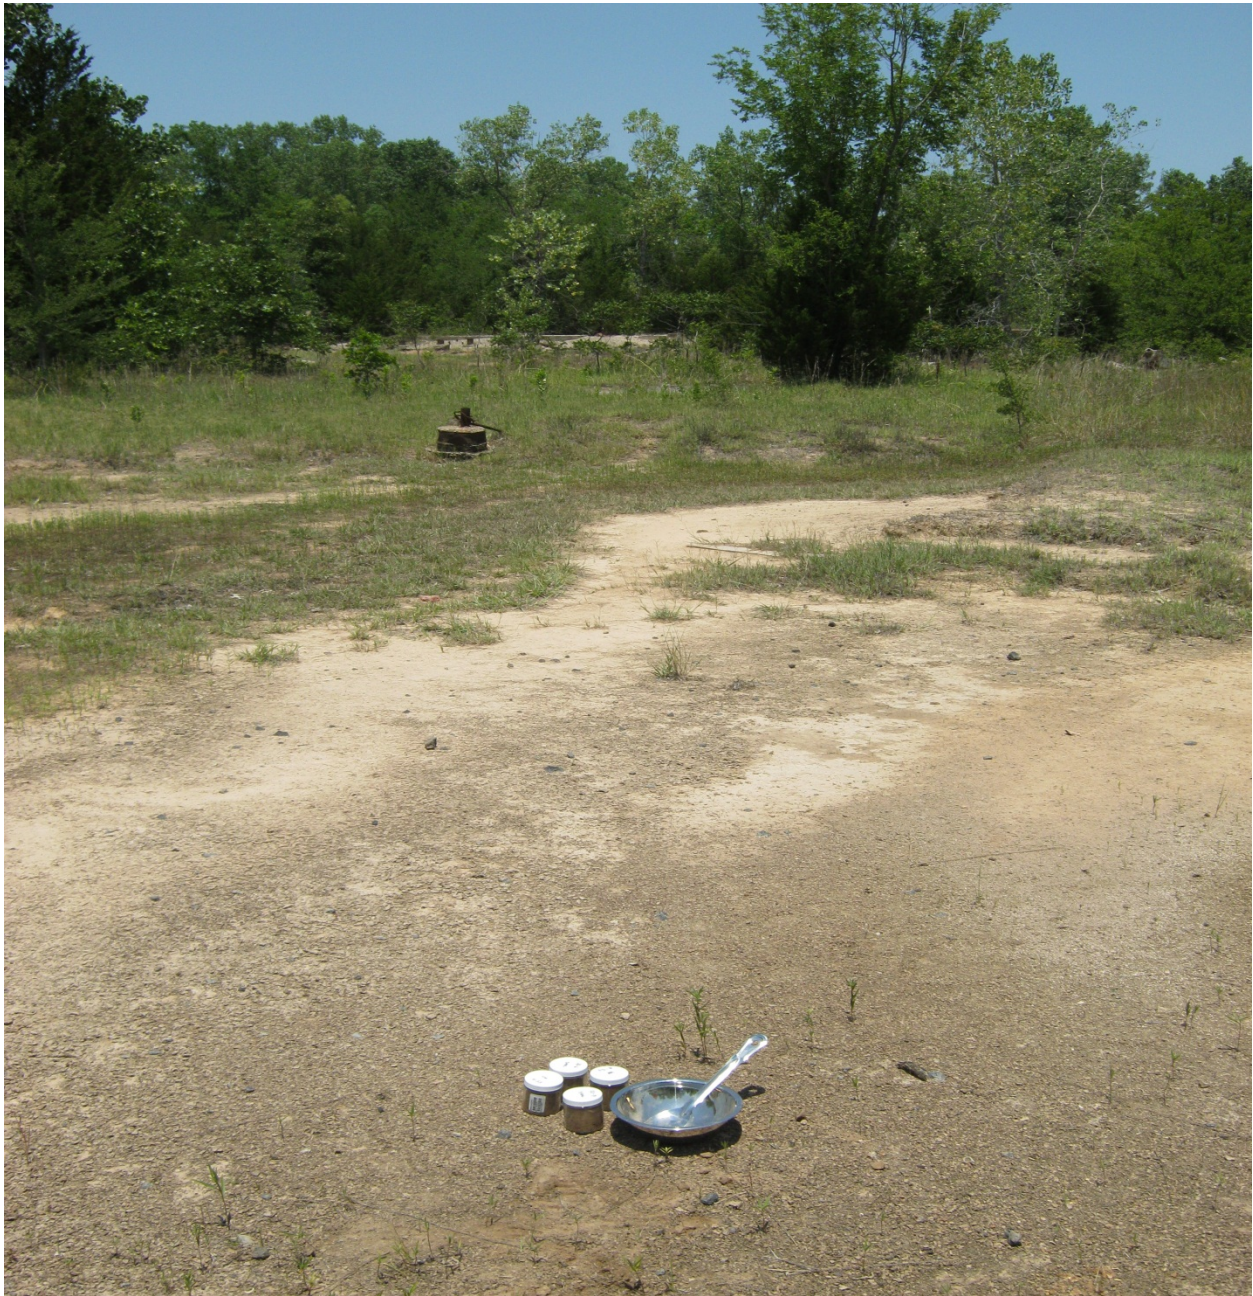
Photo #6

Photographer: Todd Downham Date: 6/28/2011 Direction: Northwest Comments: Surface Soil SS-6(7) location, large impacted area west of west tributary and pond on the Lee property.

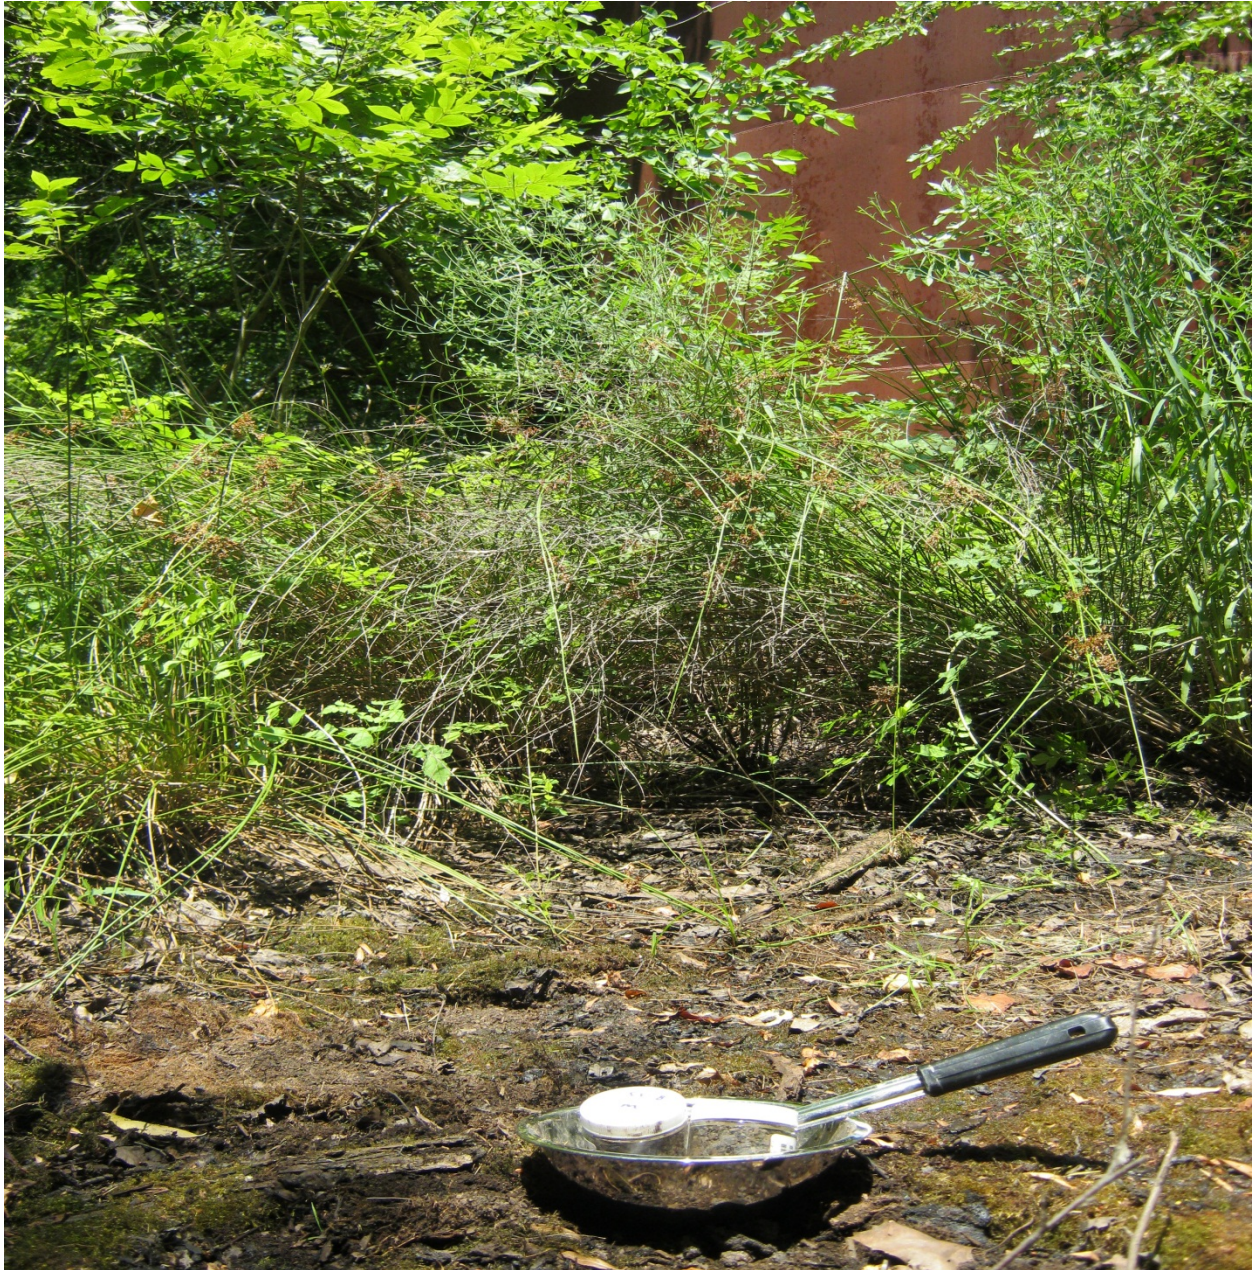
Photo #7

Photographer: Todd Downham Date: 6/28/2011 Direction: North Comments: Surface Soil SS-8 location, South of existing tank on southern boundary of site.

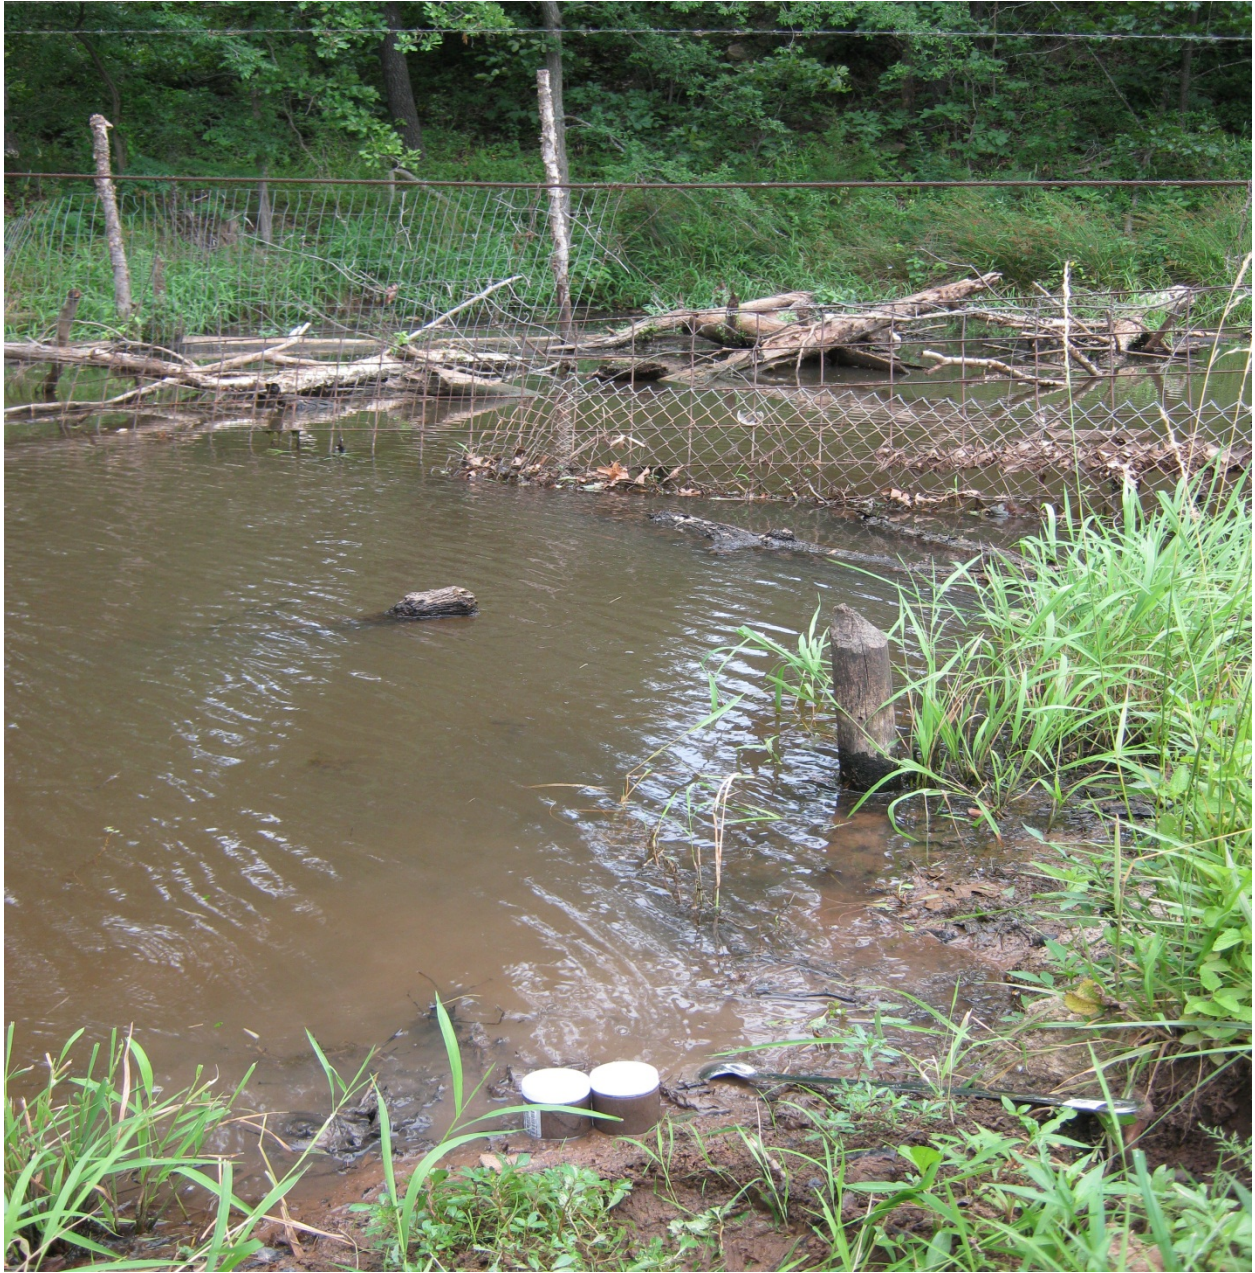
Photo #8

Photographer: Todd Downham Date: 6/29/2011 Direction: North Comments: Sediment Sample SED-1 location, East tributary near southern site boundary.

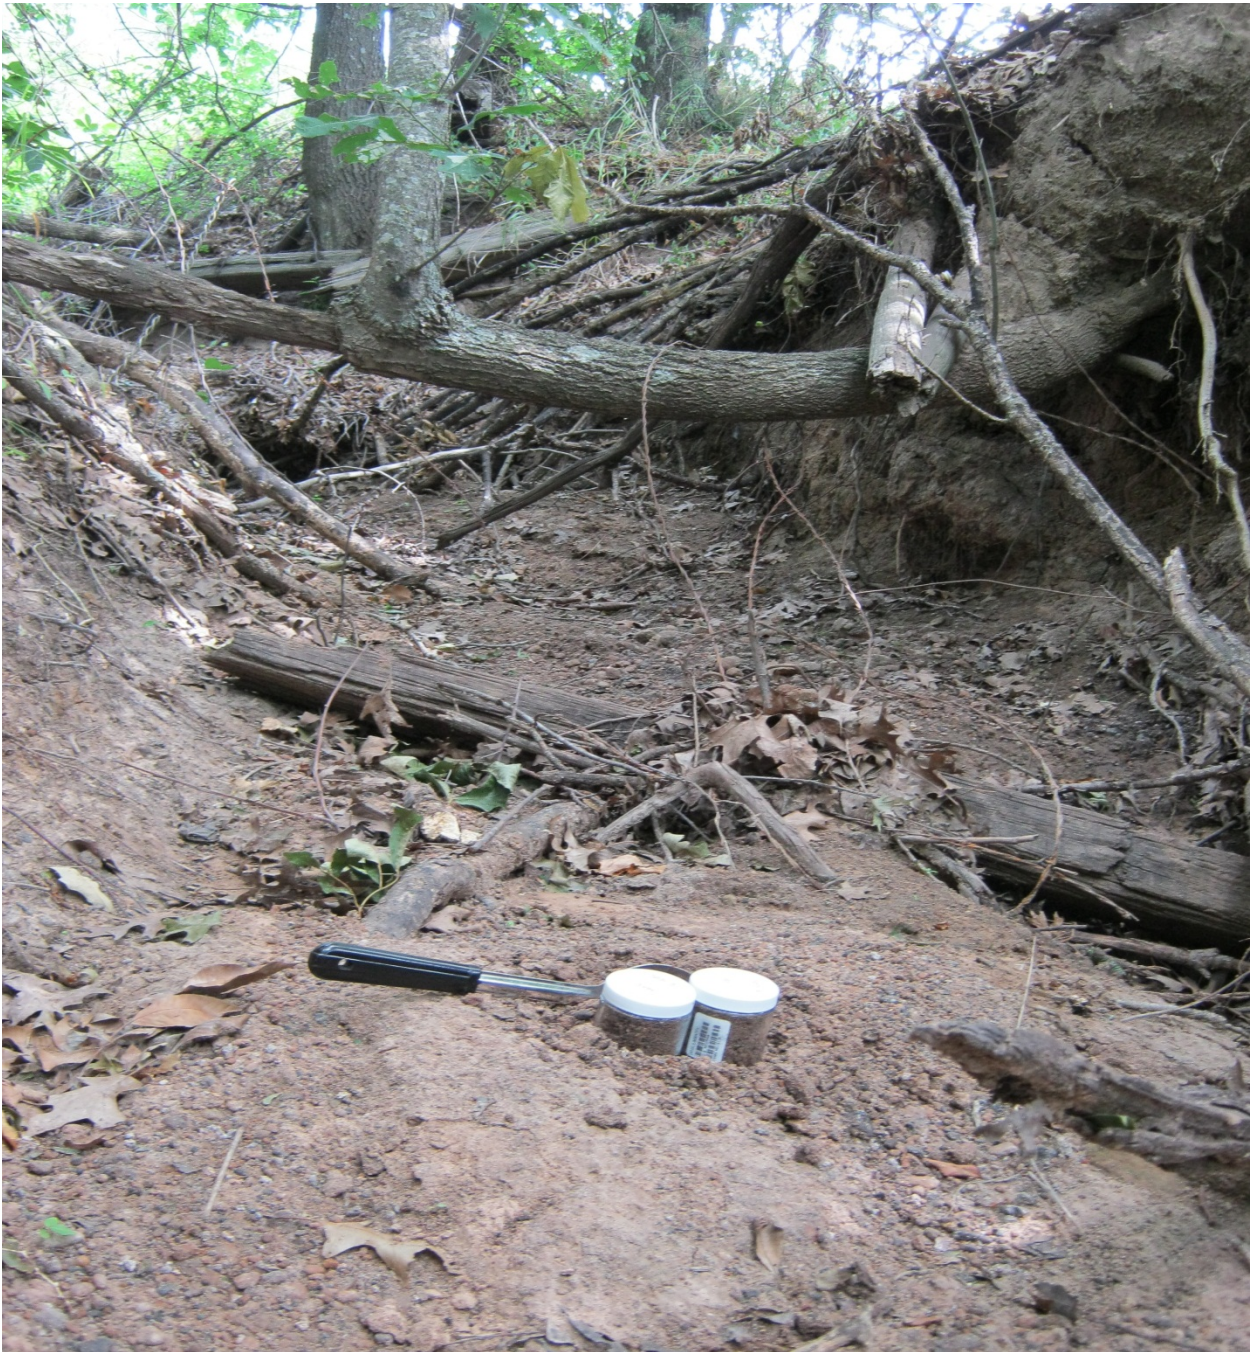
Photo #9

Photographer: Todd Downham Date: 6/29/2011 Direction: North Comments: Sediment Sample location SED-2, Drainage channel on southern site boundary that empties into Sand Creek.

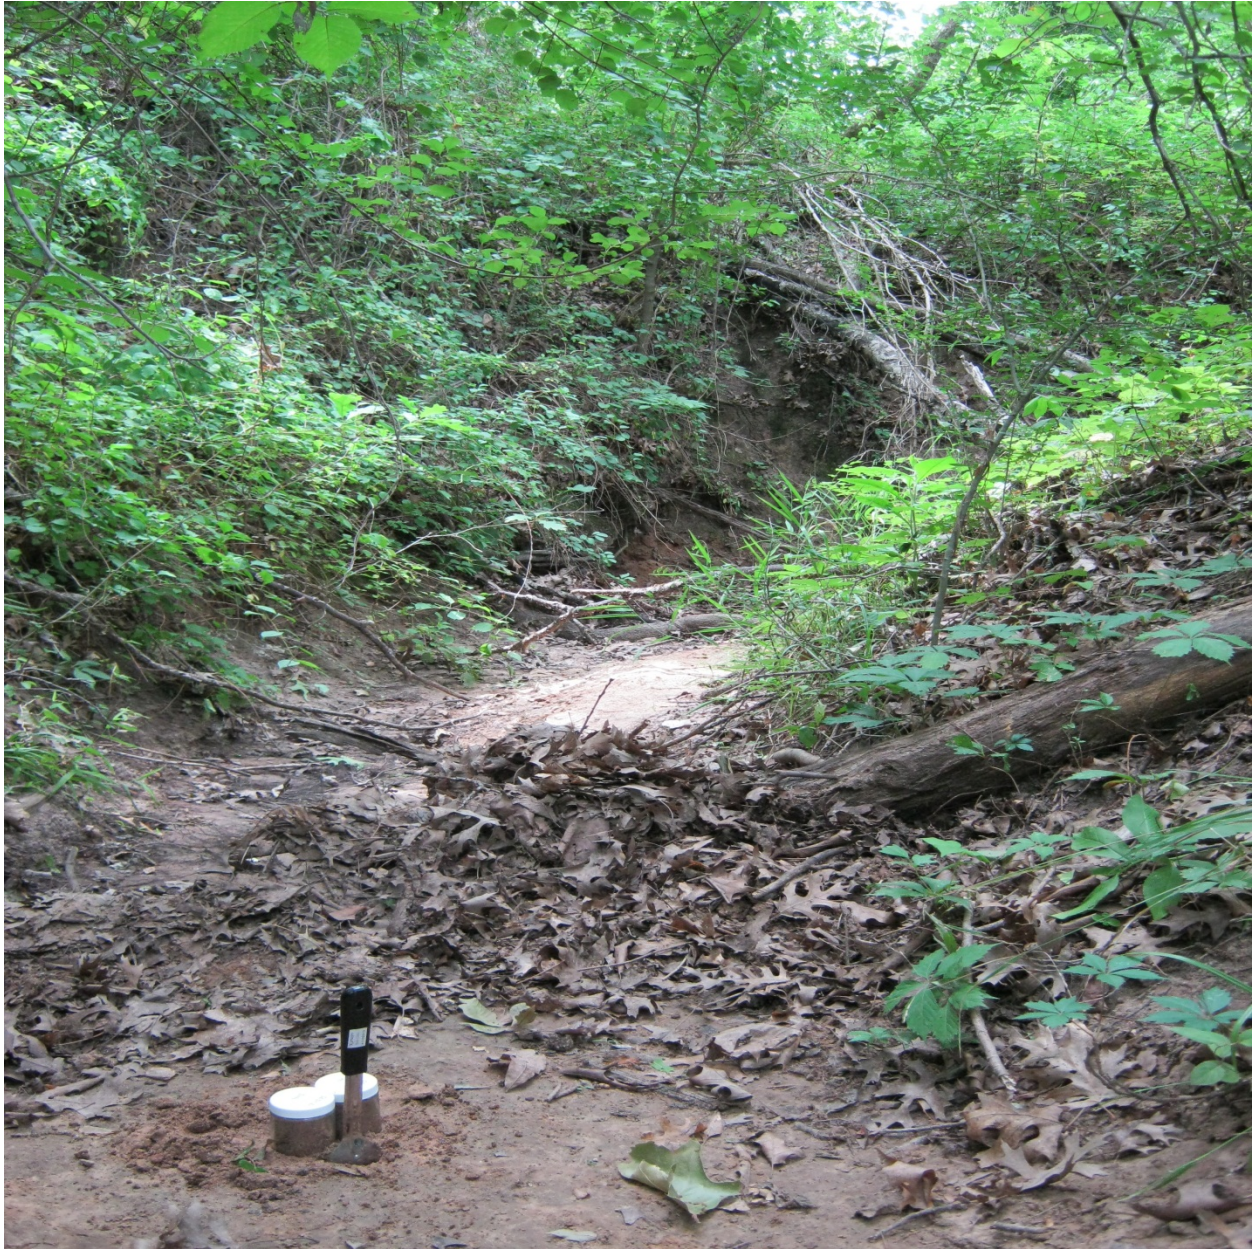
Photo #9

Photographer: Todd Downham Date: 6/29/2011 Direction: North Comments: Sediment Sample location SED-3, Drainage channel on southern site boundary that empties into Sand Creek.

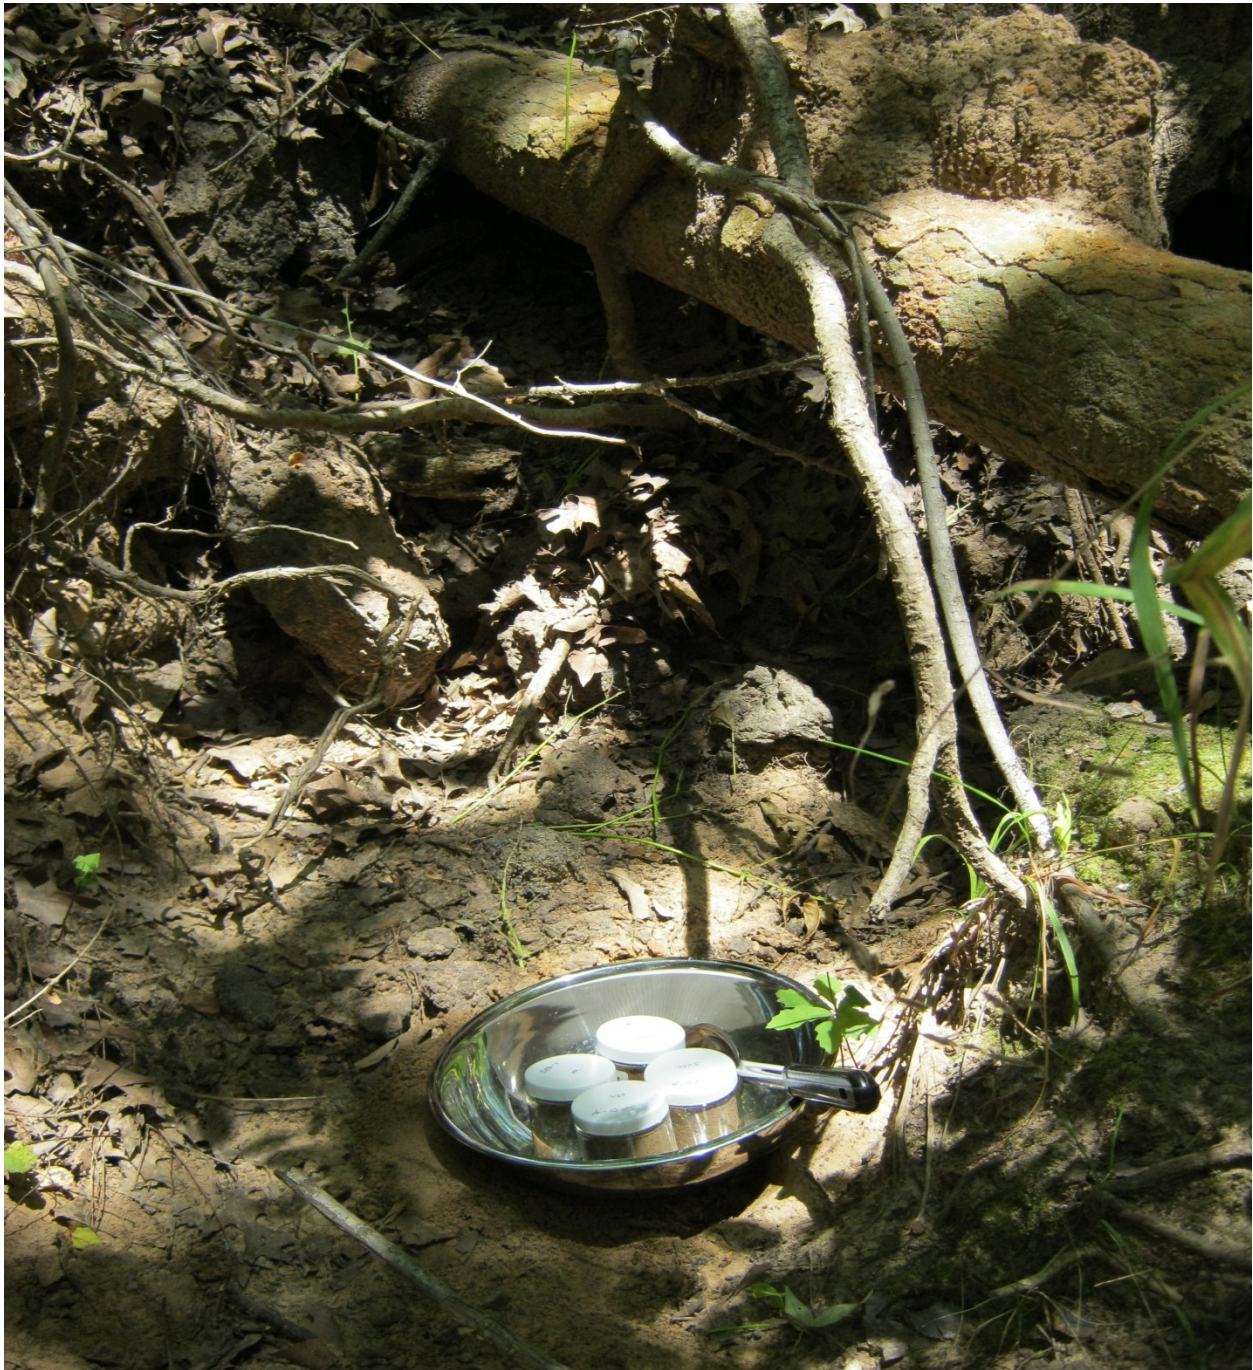
Photo #10

Photographer: Todd Downham Date: 6/29/2011 Direction: North Comments: Sediment Sample SED- 4(5) location , Drainage channel on southern site boundary that empties into Sand Creek, large amounts of waste observed.

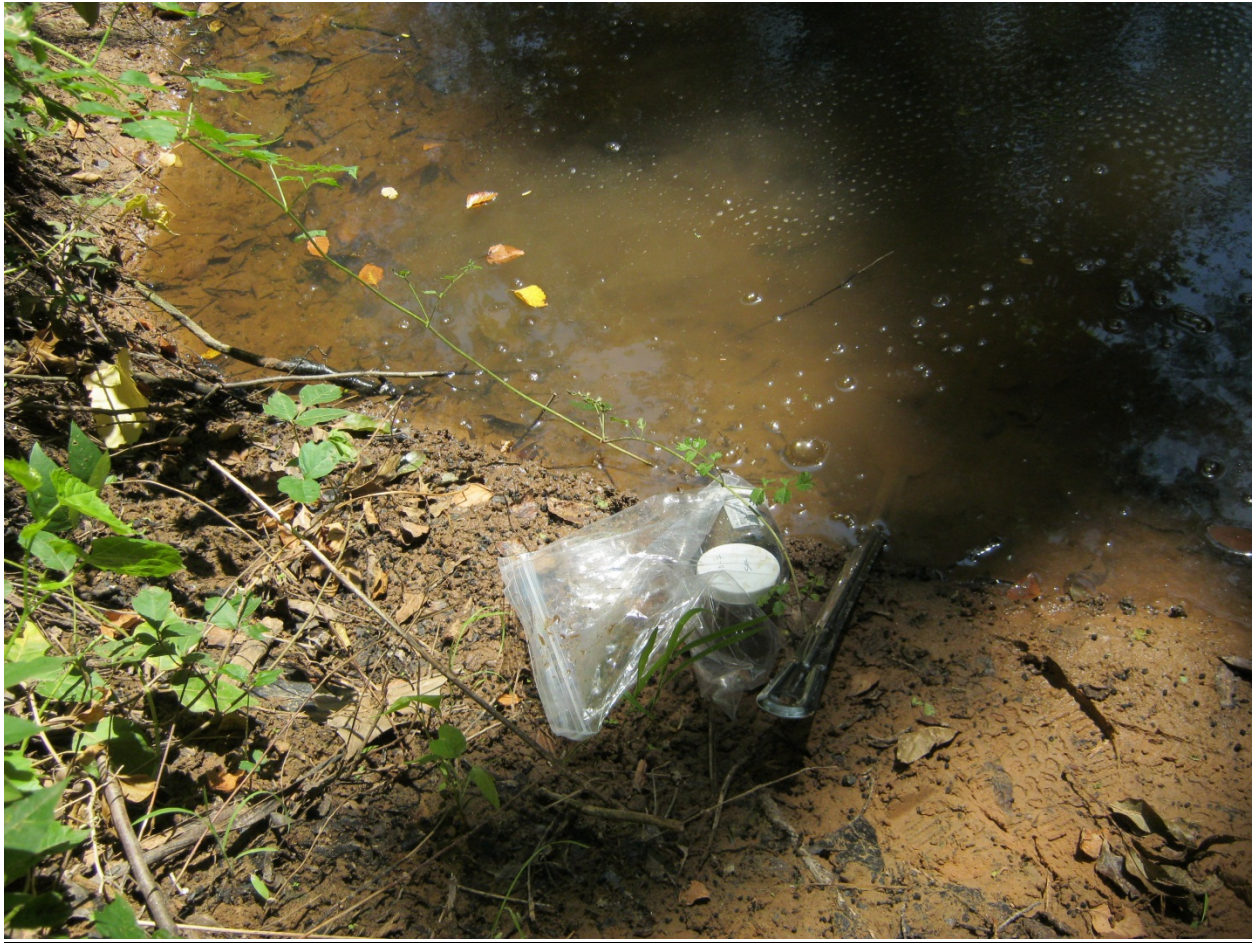
Photo #11

Photographer: Todd Downham Date: 6/29/2011 Direction: Down Comments: Sediment sample SED-7 location, Sand Creek upstream.

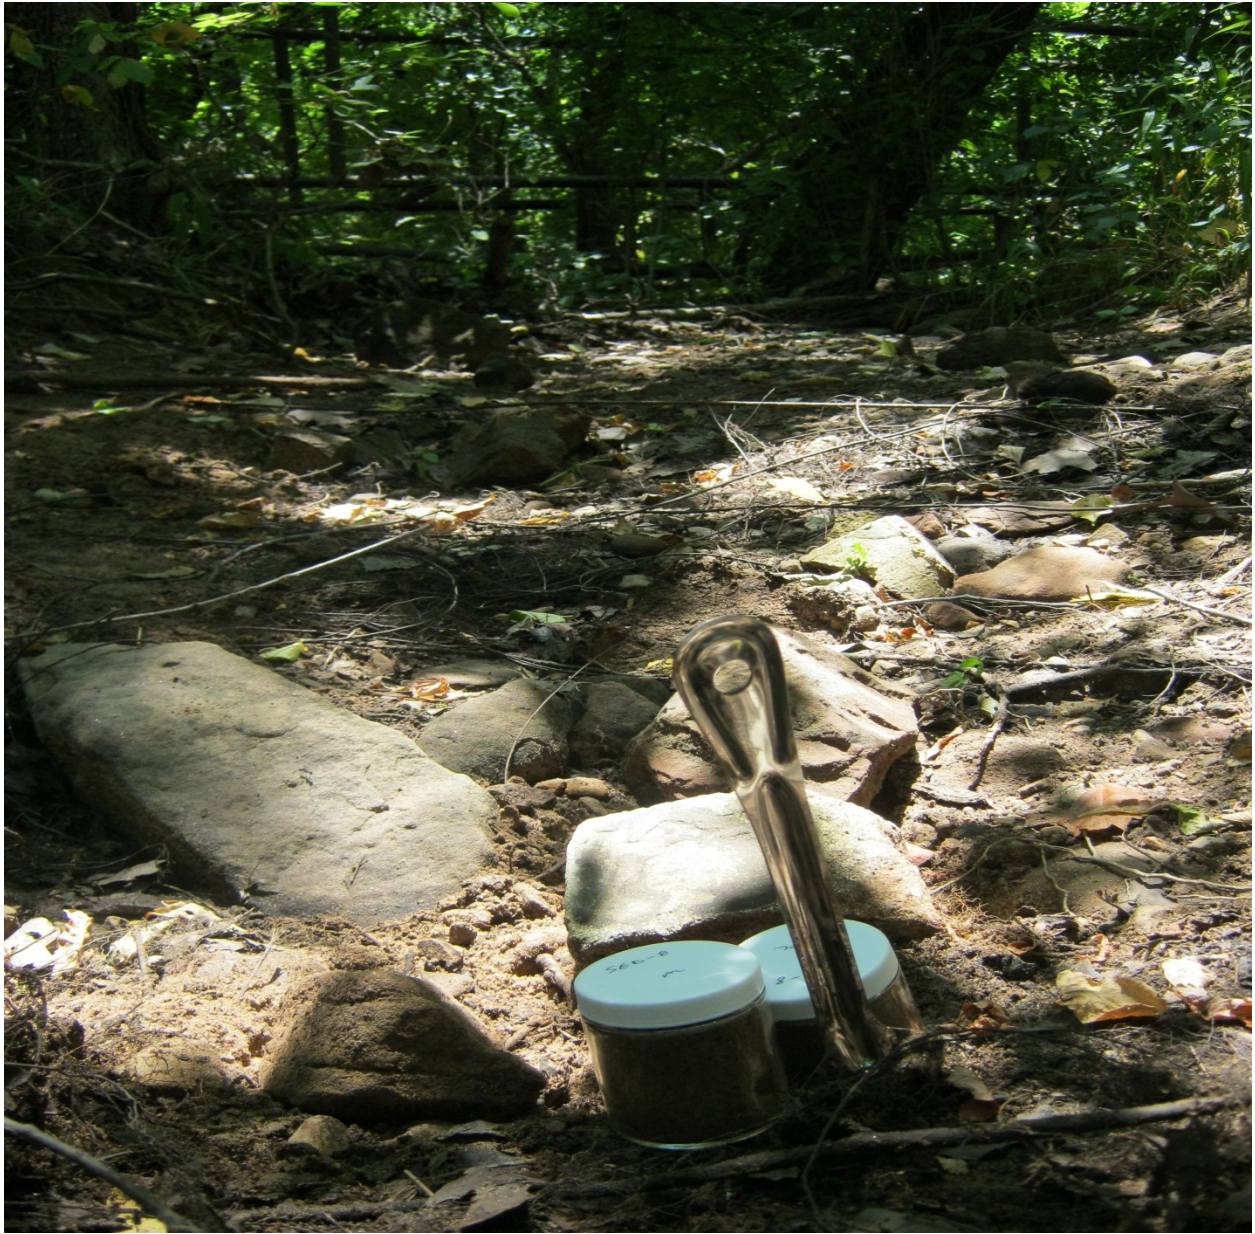
Photo #12

Photographer: Todd Downham Date: 6/28/2011 Direction: South Comments: Sediment sample SED-8 location, west tributary, north of Lee property.

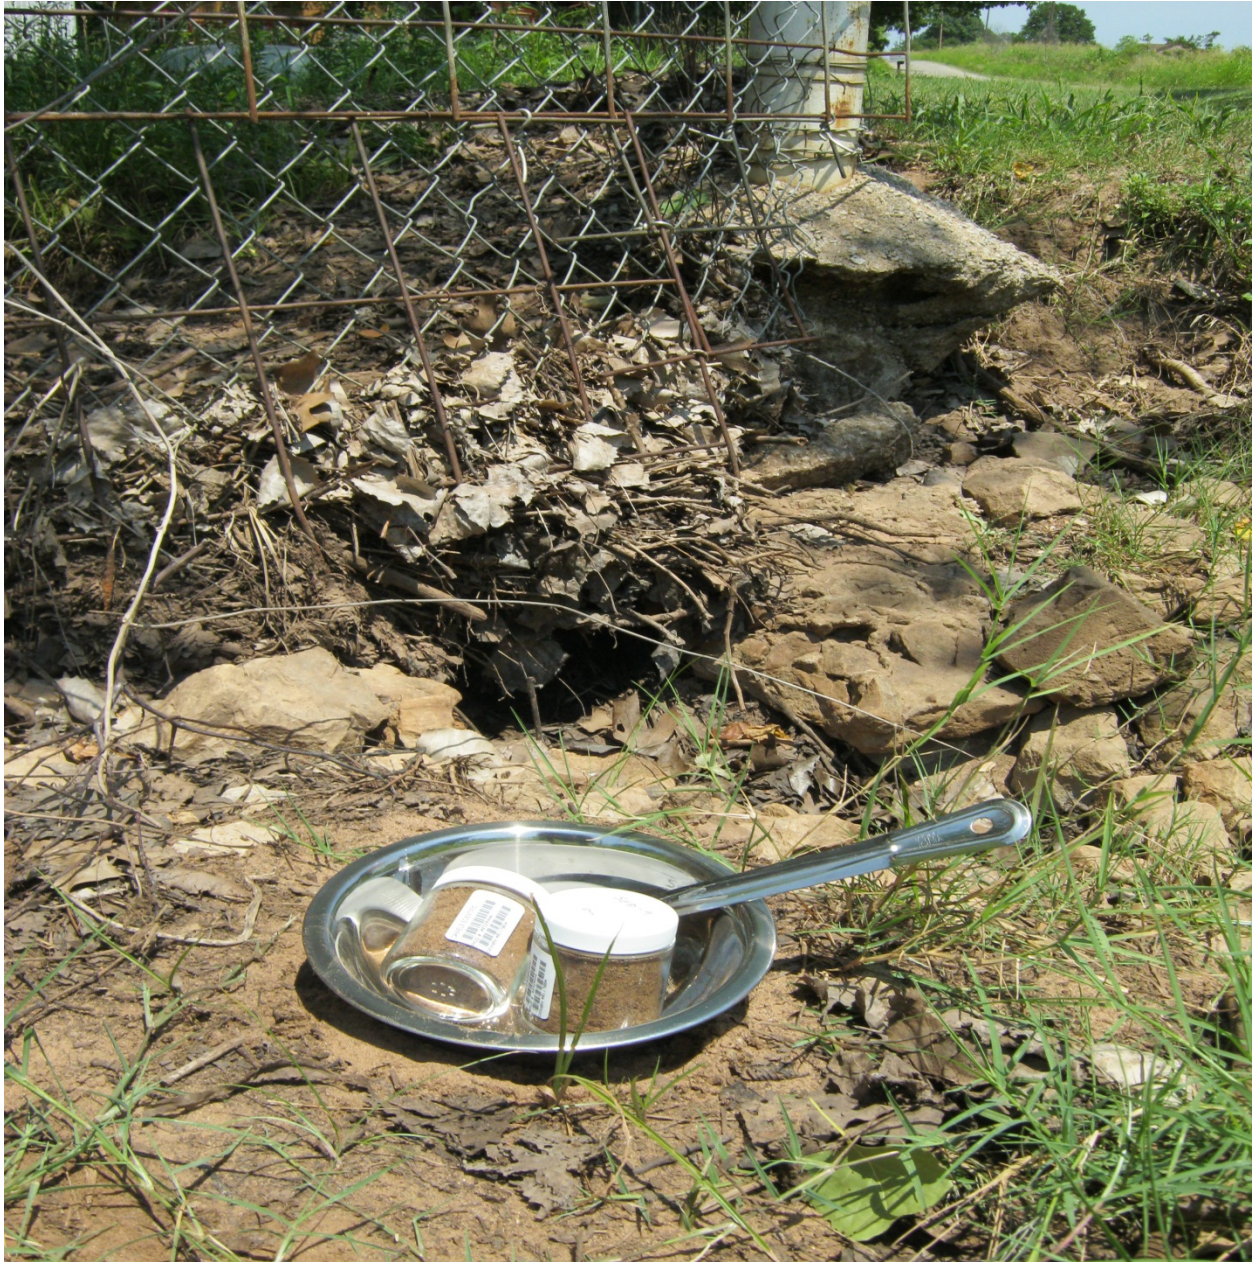
Photo #13

Photographer: Todd Downham Date: 6/28/2011 Direction: East Comments: Sediment sample SED-9 location, west tributary, north of Refinery Road.
